Monitoring Data RecordProject Title: I-540 Northern Wake Expressway (R-2000AB) COE Action ID: 200021863Stream Name: UT to Kit Creek DWQ Number: 030918City, County and other Location Information: Wake County, Site 6 (Sta.10+41 to 12+76 YRPA-)Date Construction Completed: March 2005 Monitoring Year: (5) of 5Ecoregion: _____ 8 digit HUC unit 03030002

UT Kit Creek

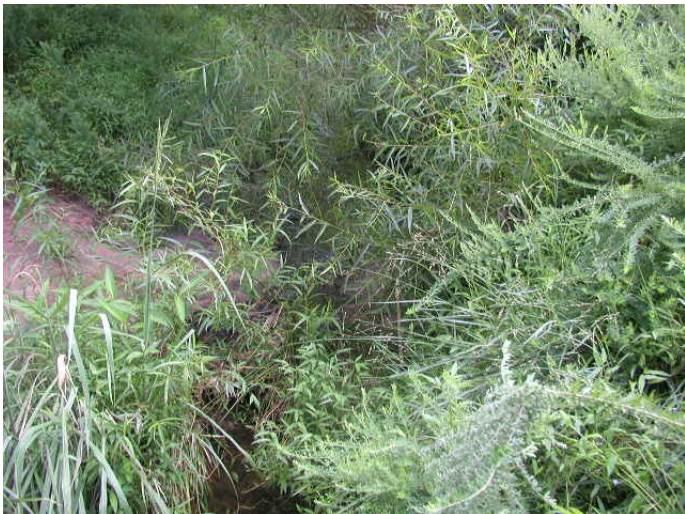
Photo Point #3 (Upstream) Larger Beaver Dam

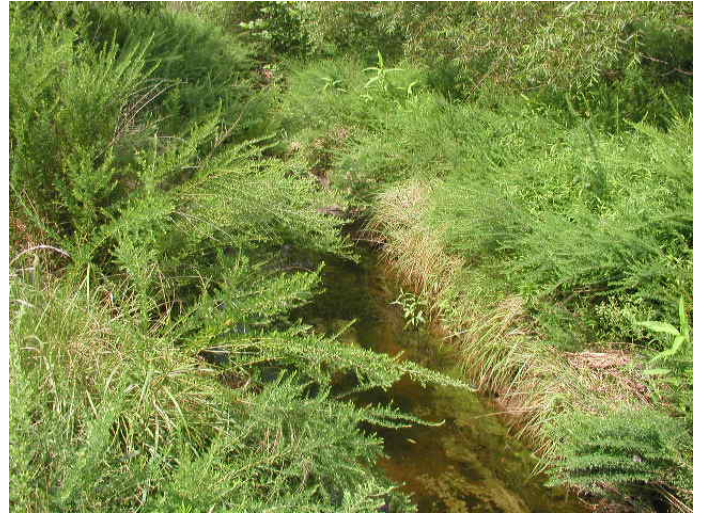
Photo Point #4 (Downstream)

The stream is stabilized for the Year 5 Summer evaluation, except for a crossvane at Sta. 2+00 –Stream 1- (downstream of Photo Point #4) that had water piping under the crossvane at the time of monitoring. The stream bed consists of mainly Triassic Rock which is a contributing factor to the water flowing under this crossvane. There was also a low flow of water at the time of monitoring. A beaver dam was located on site at Sta. 0+90 (next to Photo Point #2). USDA has been contacted to trap the beavers and breach the dam. There have been a total of six bankfull events visually documented during the five year monitoring evaluation. The dates the bankfull events were visually noted are as follows: 9/12/06, 3/14/07, 8/9/07, 1/14/08, 6/11/08, 1/28/09, 7/6/09. NCDOT proposes to discontinue channel stability monitoring at the UT to Kit Creek stream relocation.

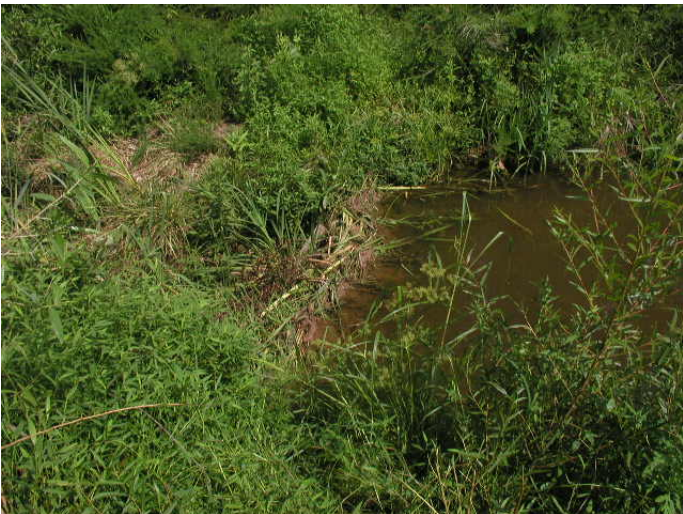
Date 7/29/10	Station Number 0+90 –Stream 1- (Additional Photo)	Station Number 2+00 –Stream 1-	Station Number	Station Number	Station Number
Structure Type		Crossvane			
Is water piping through or around structure?		Water piping under crossvane			
Head cut or down cut present?					
Bank or scour erosion present?					
Other problems noted?	Beaver dam noted

Photo of Beaver Dam at Sta. 0+90 –Stream 1-
